NASA TM X-73401

D-1A EQUIPMENT MODULE STRUCTURE TEST

by T. F. Niezgoda
Lewis Research Center
Cleveland, Ohio 44135
April 1976

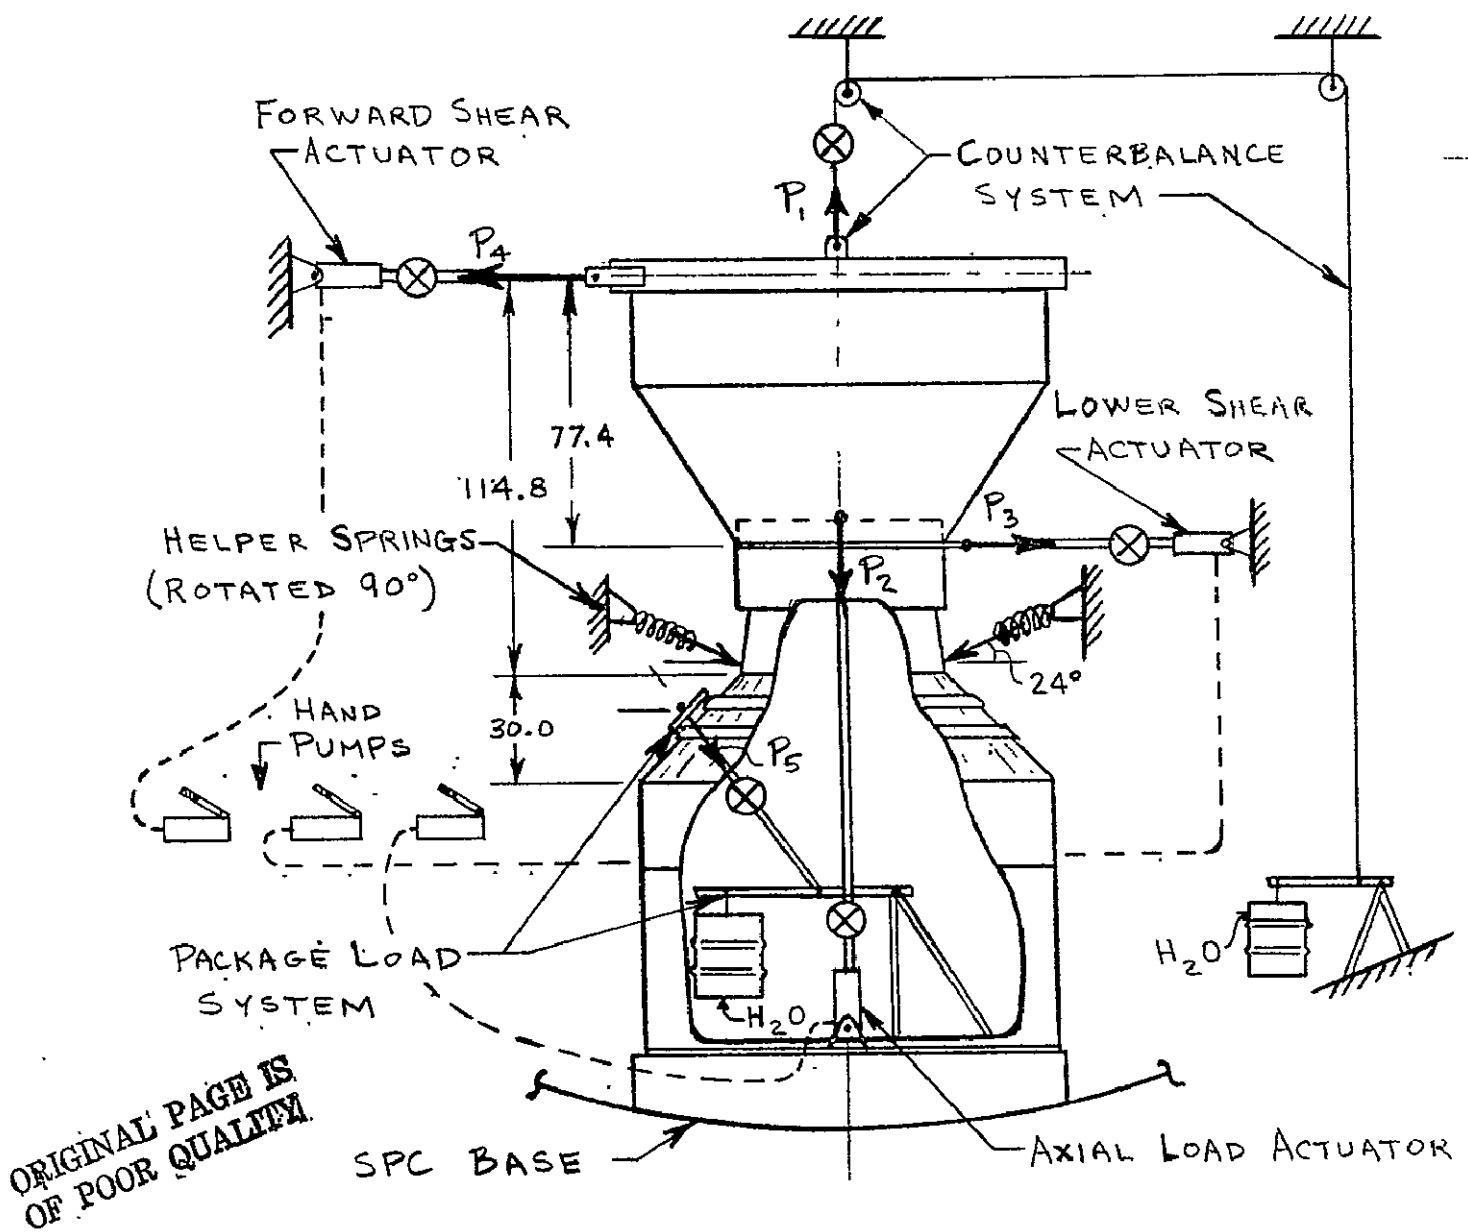
FIGURE 3 EQUIPMENT MODULE TEST LOADING SYSTEM
USING INTELSAT IV ADAPTER

Beginning with the stiffness tests, the arrangement of shear load actuators shown in Figure 3 allowed loading the E/M with pure shear or pure bending moment. The axial load could also be applied individually. These loads were applied separately up to 80 percent of design limit while deflection measurements were taken with a dial gage at certain positions. See Tables 1, 2, and 3 and Figures 11, 12, and 13 for the tabulated values and locations of these deflection measurements. The E/M deflected linearly with load and showed good repeatability in the data. A flexibility matrix was determined from these data. A comparison of the analytical and actual flexibility matrices is shown in Figure 14, and the recommended matrix is shown at the bottom of this figure. This flexibility matrix is used to predict launch and flight loads during an Atlas/Centaur flight.

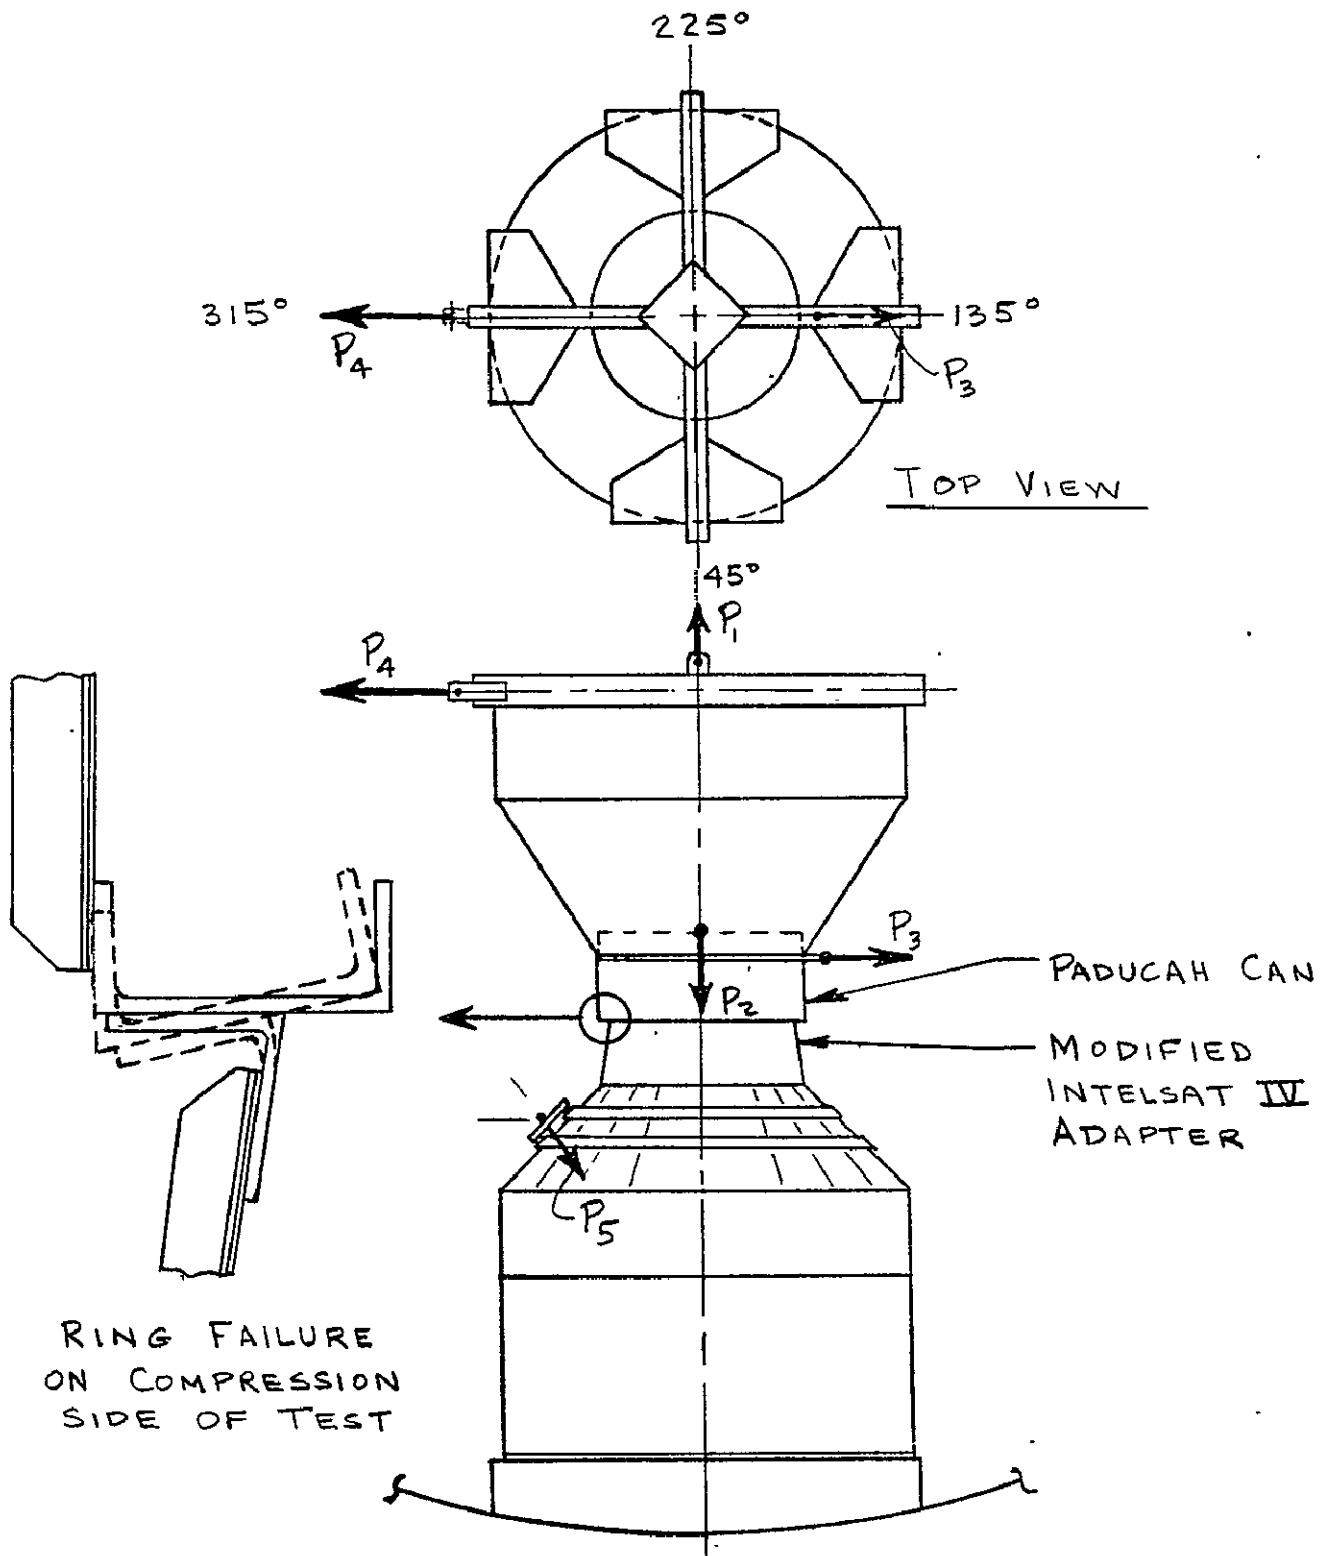
The first E/M failure test was attempted on December 11, 1974. Table 5 describes the loading sequence and test procedure which concluded with the ring failure at the MPA--Paducah can interface. The mode of ring failure shown in Figure 15 was attributed to the eccentric load path followed by the longitudinal line load due to bending moment and axial load. At the moment of failure, the axial load was 20,000 pounds and the shear load was 21,000 pounds which developed a bending moment of 2.411×10^6 in-lb at the forward ring of the E/M. This combined loading resulted in an equivalent axial compressive load of 180,700 pounds.

FIGURE 15 EQUIPMENT MODULE TEST WITH INTELSAT IV
ADAPTER ILLUSTRATING THE TYPE OF
RING FAILURE ON THE TEST HARDWARE

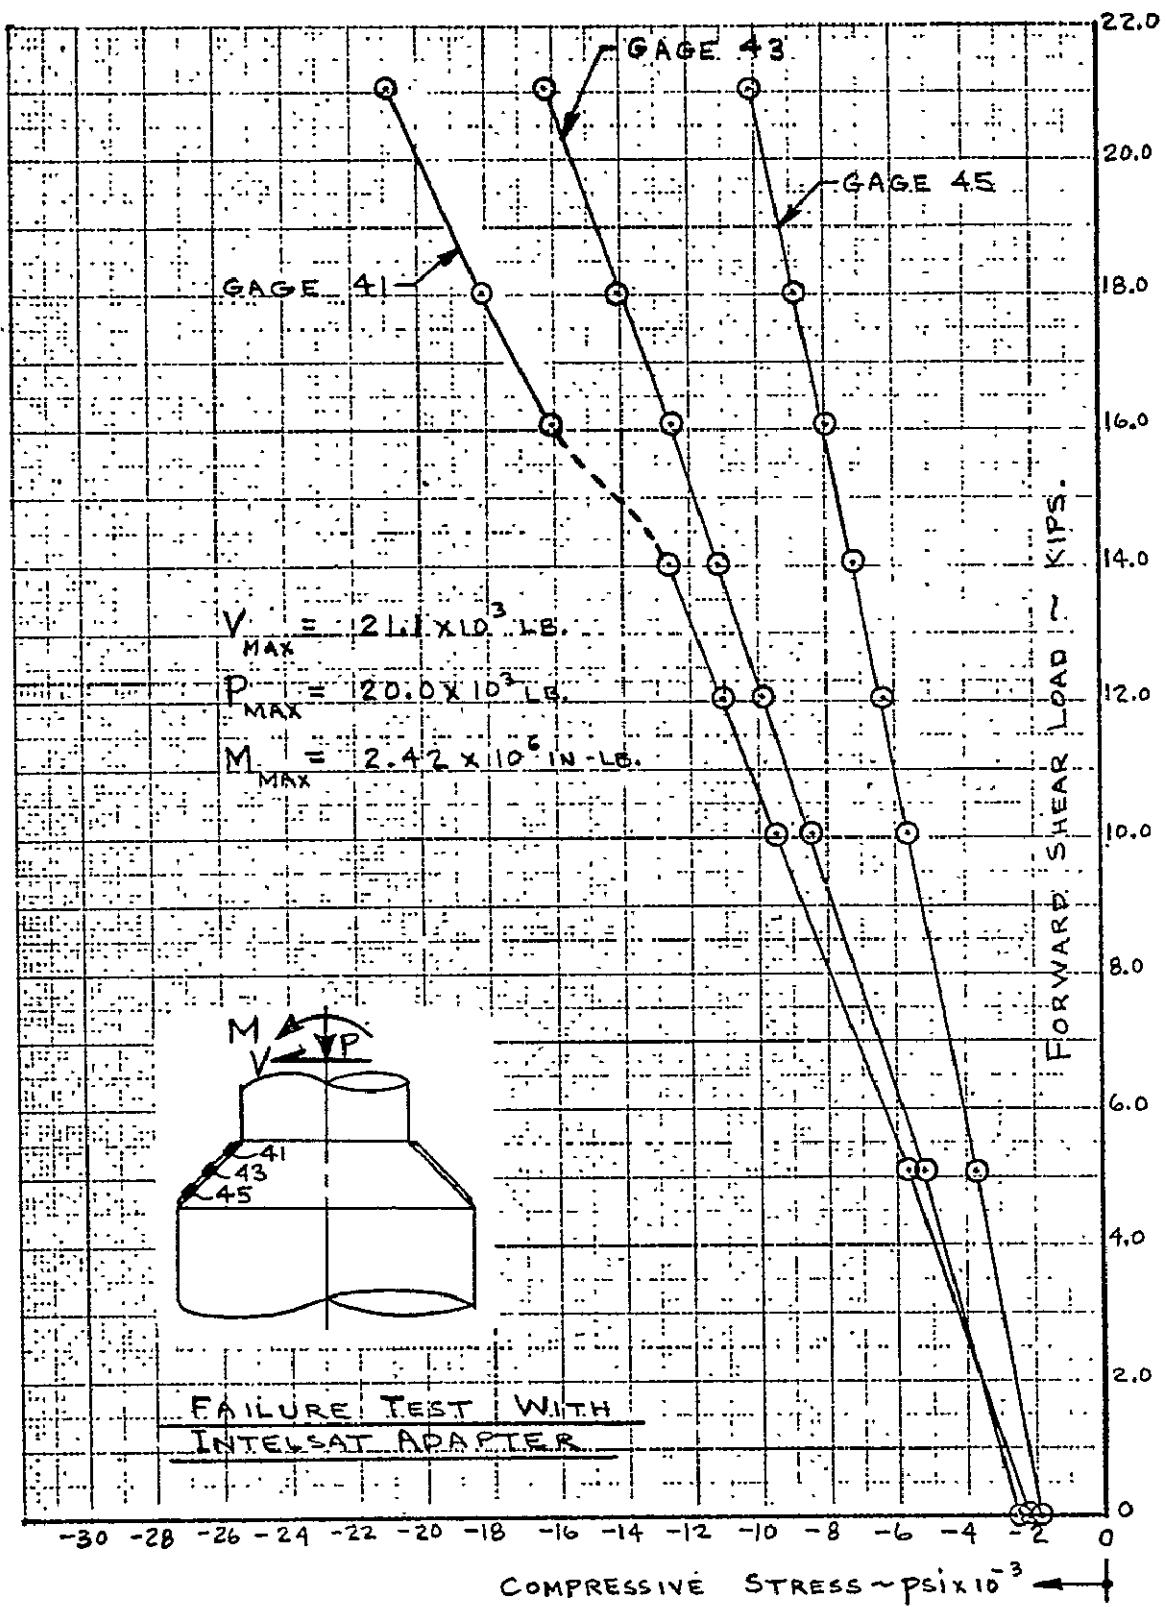
FIGURE 16 MAXIMUM COMPRESSION STIFFENER STRESS VS. FORWARD SHEAR LOAD

Strain gage data indicated that the E/M was responding linearly and that there was no permanent set in any of the E/M structure. Figures 16 and 17 show some stresses versus the forward shear load. Maximum normal stress of 20,874 psi occurred in the 315 degree stiffener near the forward ring of the E/M. The maximum measured shear stress of 29,684 psi occurred in the skin near the forward ring of the E/M, 90 degrees away from the shear load direction. Because of distortions in the Intelsat IV MPA, some of the deflection measurements did not provide reliable data. Table 6 summarizes all the tests performed in this series of tests with the Intelsat IV MPA.

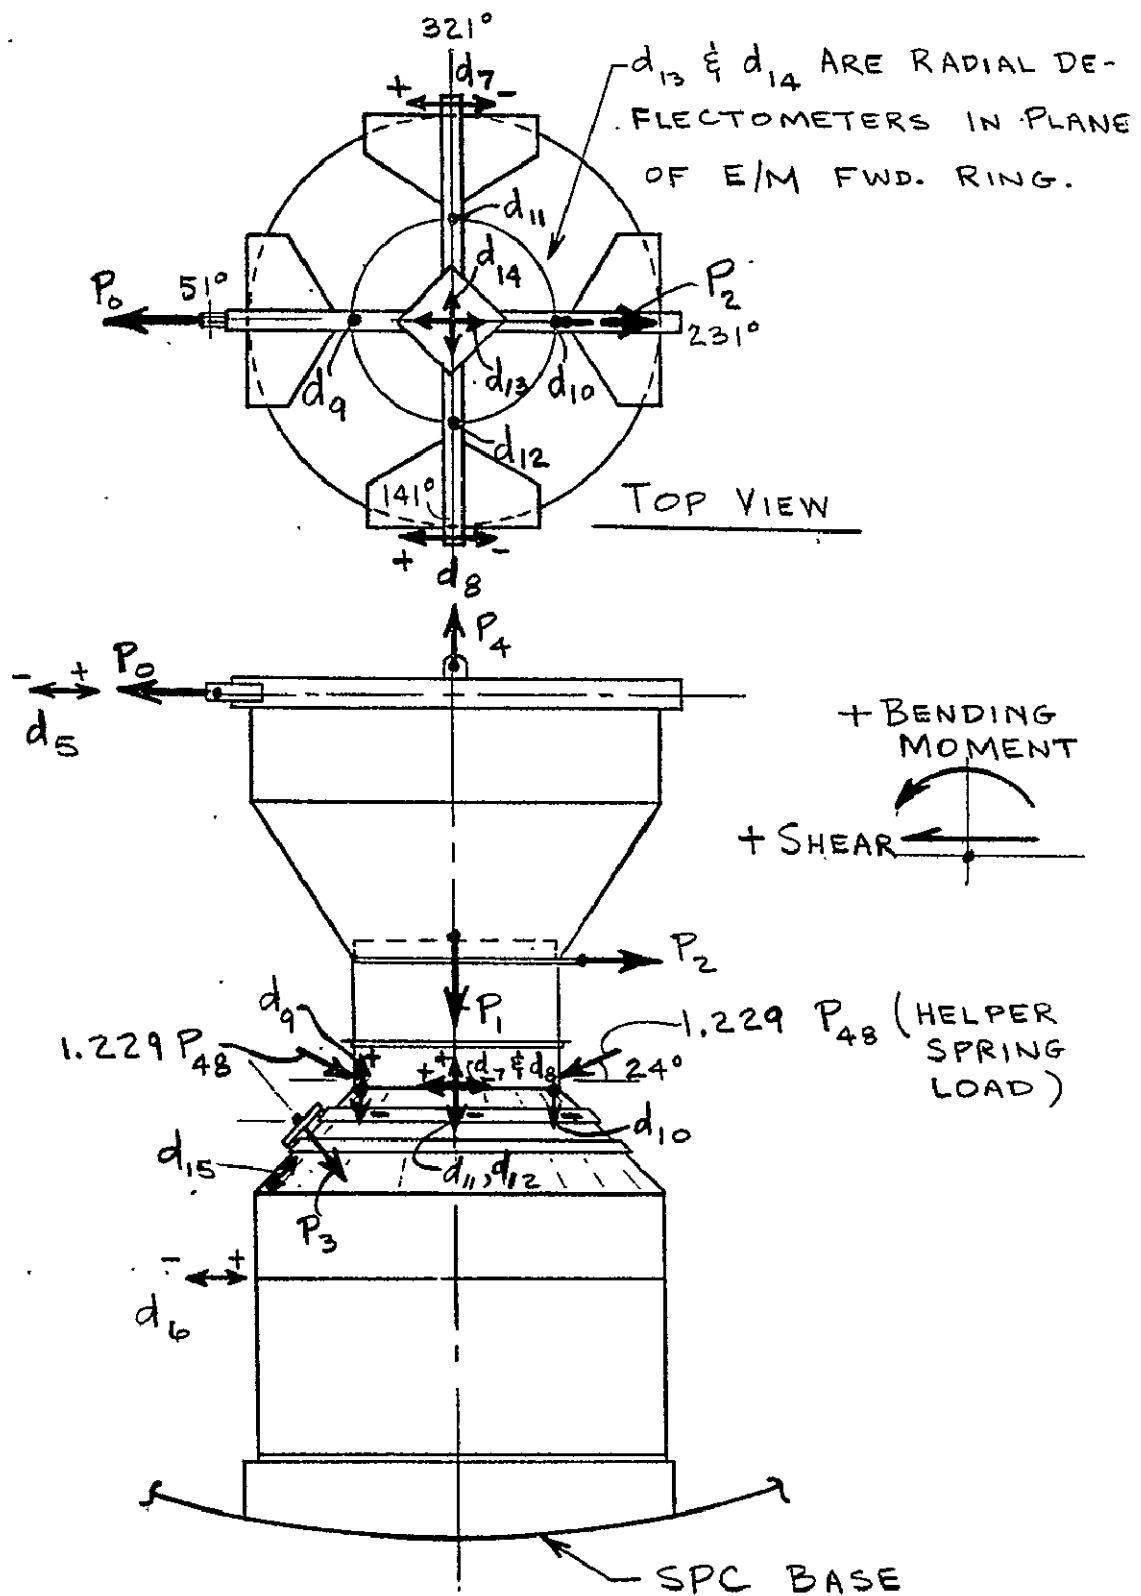
FIGURE 18 EQUIPMENT MODULE TEST WITH SIMULATED HEAD
MISSION ADAPTER SHOWING DEFLECTOMETER
LOCATIONS

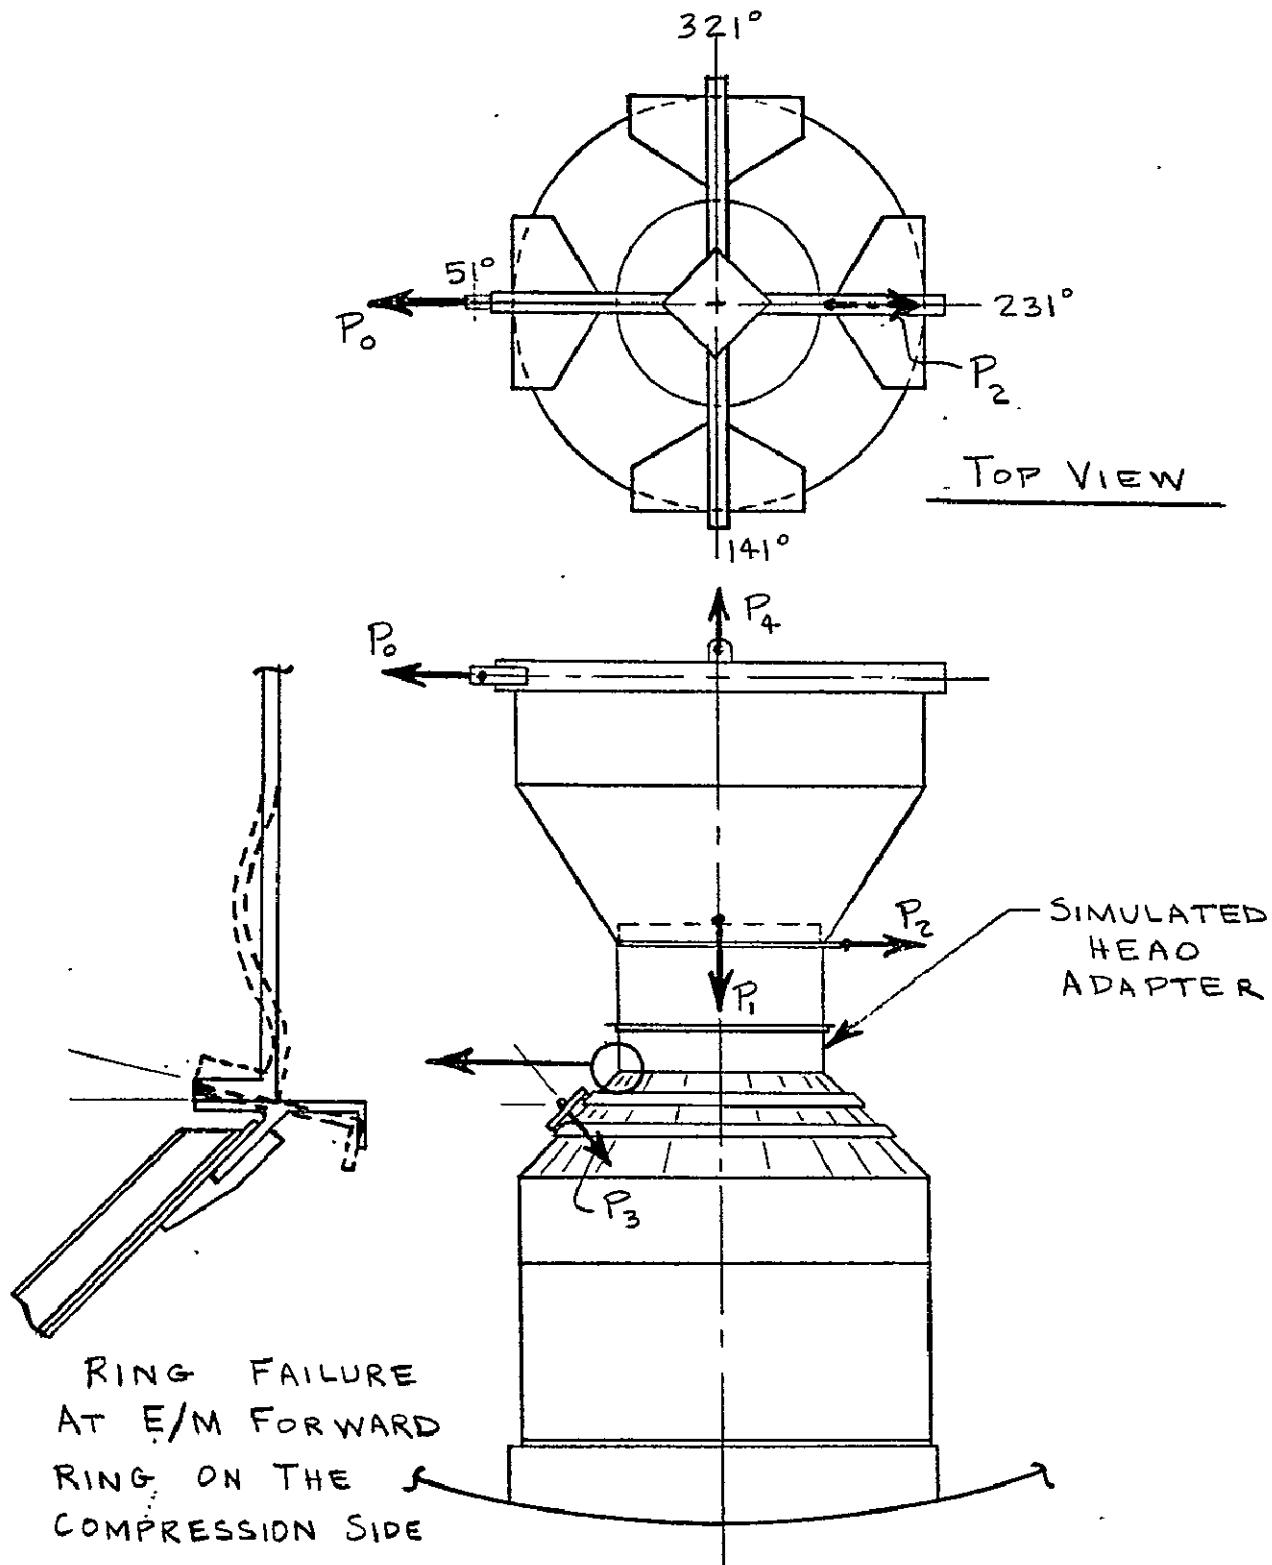
Inspection of the structure after all the loads were removed revealed that the buckling of the simulated HEAO adapter on the high compression side was the point of structural failure. Figure 23 illustrates the type of buckling failure which distorted the simulated HEAO adapter ring and the forward ring of the E/M. Figure 24 is a photo of the same point showing the 11-degree ring distortion and Figure 25 is an internal view. The opposite tension side shows the 0.085 inch gap between the interface rings of the adapter and E/M shown in Figure 26. The E/M forward ring did return to 3.5 degrees when the simulated HEAO adapter was removed and the diameter returned to its original circular shape with no permanent set. Figure 27 shows the axial deflection of the forward end of the E/M on the compression and tension sides and gives an indication of symmetrical plane rotation. Figure 28 shows the E/M forward ring plane rotation and compares it to the predicted values. The test values are in good agreement with the predicted loads up to about 13,000 pounds of shear where significant non-linear deflection began to occur. The stiffener stresses indicated a linear response to loading, in general, except for the points near the forward end of the E/M reflecting the distortion of the adapter ring and E/M forward ring. Figures 29 through 31 illustrate the strain gage data versus load for some of the more significant stiffeners at the high compression azimuth and the highest tension azimuth. The maximum shear stress measured occurred in the skin at the 324 degree azimuth near the forward E/M ring (see Figure 9), and its value was 35,750 psi.

Previously, it was noted that the simulated HEAO adapter had provision for mounting the helper spring longerons every 90 degrees on the skin of the adapter. Part of this provision was several drilled holes through the skin at these points, and during this failure test, the helper spring fixture was mounted perpendicularly to the applied shear load. This left the high compression side unsupported and the stress concentration at these holes could have caused the skin to yield and buckle, thus precipitating the ring roll. Therefore, the E/M might have supported more load than this test indicated.

FIGURE 23 EQUIPMENT MODULE TEST WITH SIMULATED HEAD ADAPTER ILLUSTRATING THE RING FAILURE AT FORWARD E/M INTERFACE.

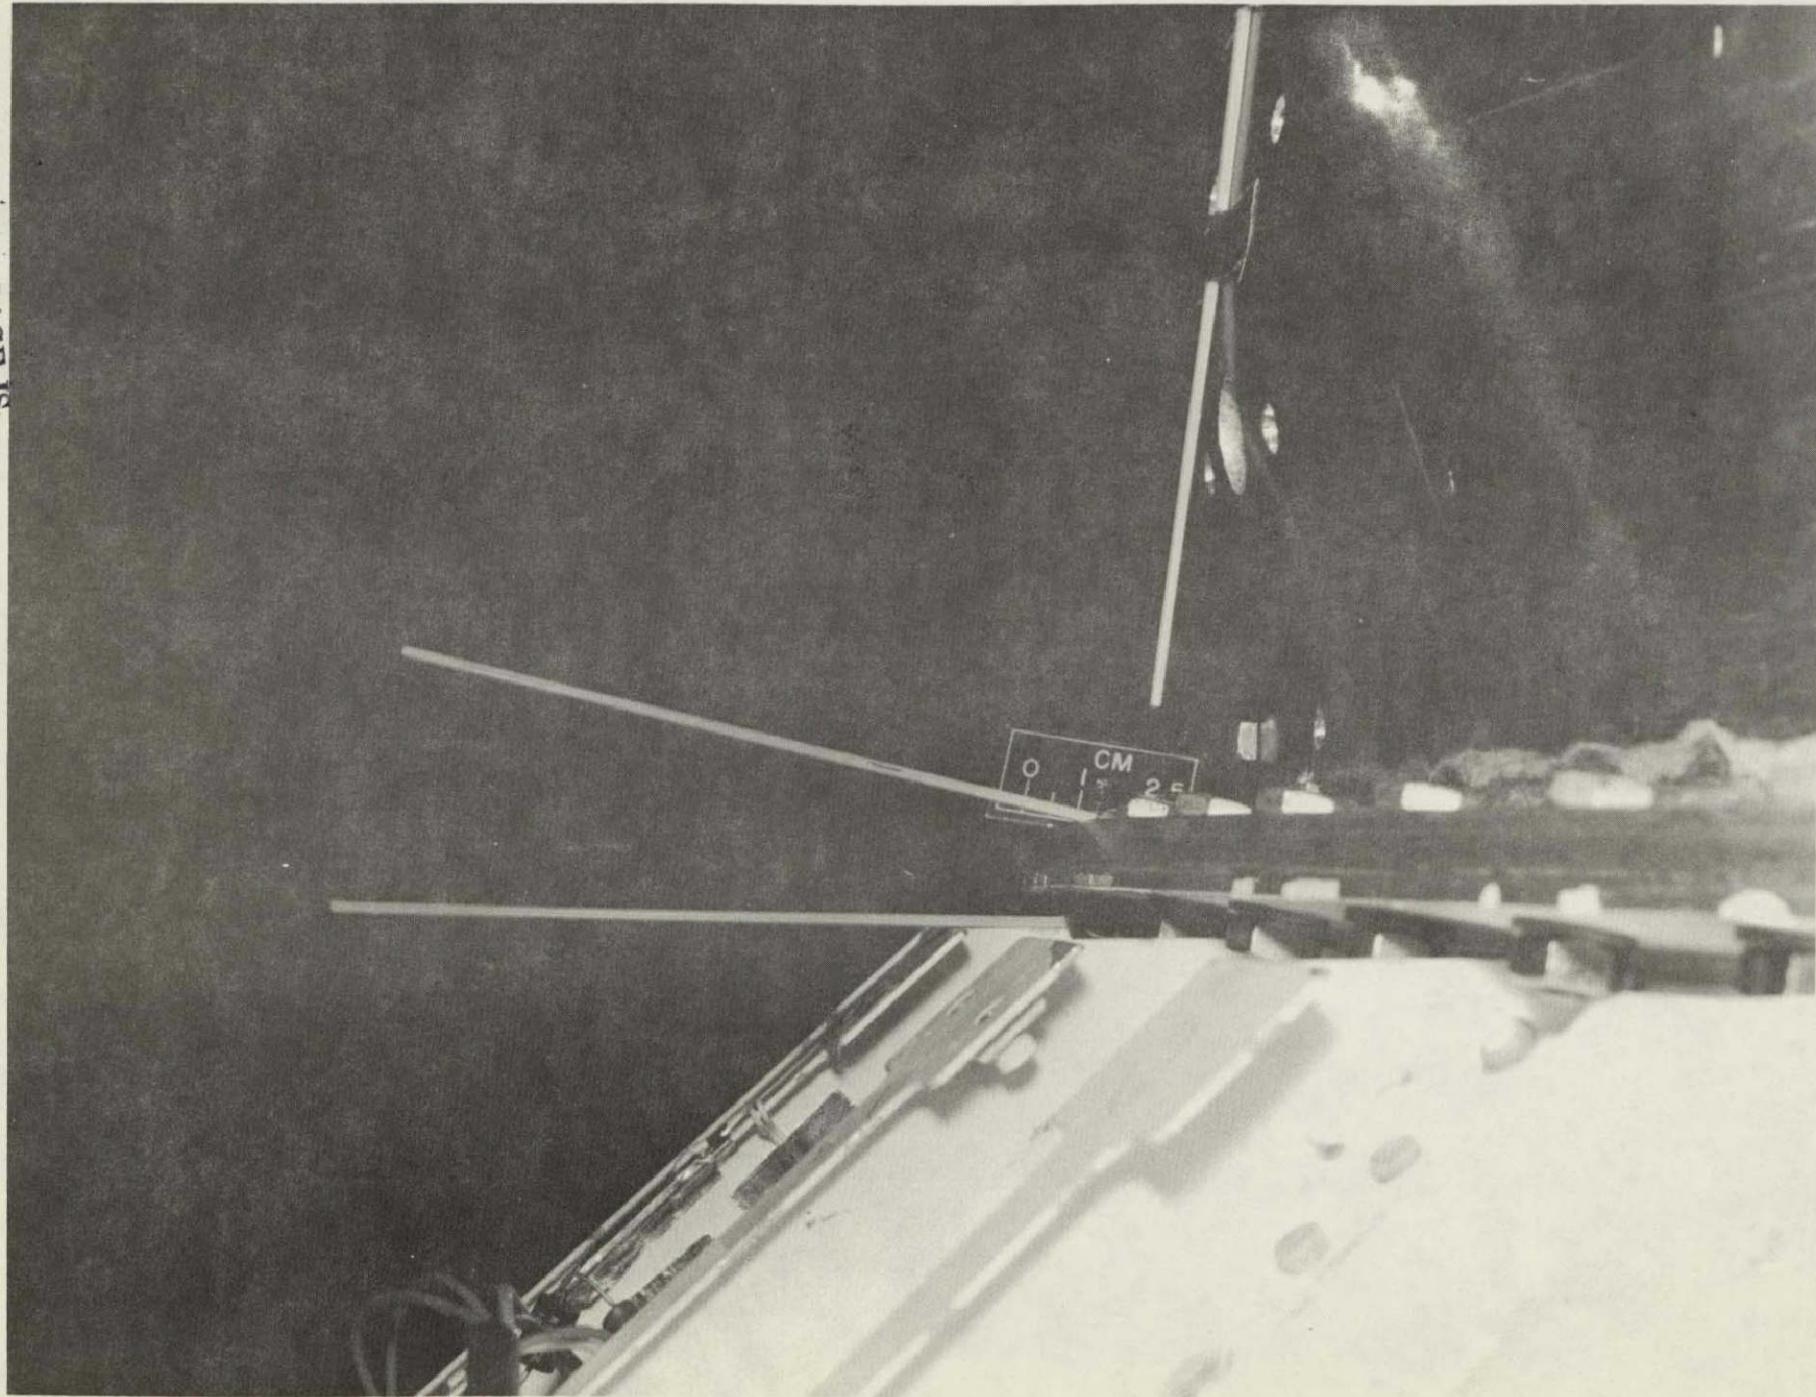
3. The ultimate strength failure test was performed resulting in the E/M forward ring failure indicated by the permanent set in the ring (3.5 degrees of ring roll). The maximum loads at the E/M forward ring were:

Although the E/M forward ring did indicate a structural failure by rolling and being permanently set at 3.5 degrees, it is possible that the ultimate strength of the E/M was compromised by the simulated HEAO adapter mounted on the forward ring of the E/M. The 6061 aluminum of the simulated HEAO adapter was in the annealed condition at the interface of the E/M forward ring due to welding of its aft flange. This drastically reduced the yield strength of the adapter in this region and could have precipitated the ring roll due to the high compression at the point of failure. This possibility is suggested by the fact that the HEAO adapter's ring remained at about 11 degrees after being separated from the E/M while the E/M ring sprang back to about 3.5 degrees. Also, the adapter gapped at the high tension side and remained permanently set while the E/M ring had very little indication of any yielding on the high tension side.

FIGURE 24 - EXTERNAL VIEW OF DISTORTION IN E/M FORWARD RING ON COMPRESSION SIDE

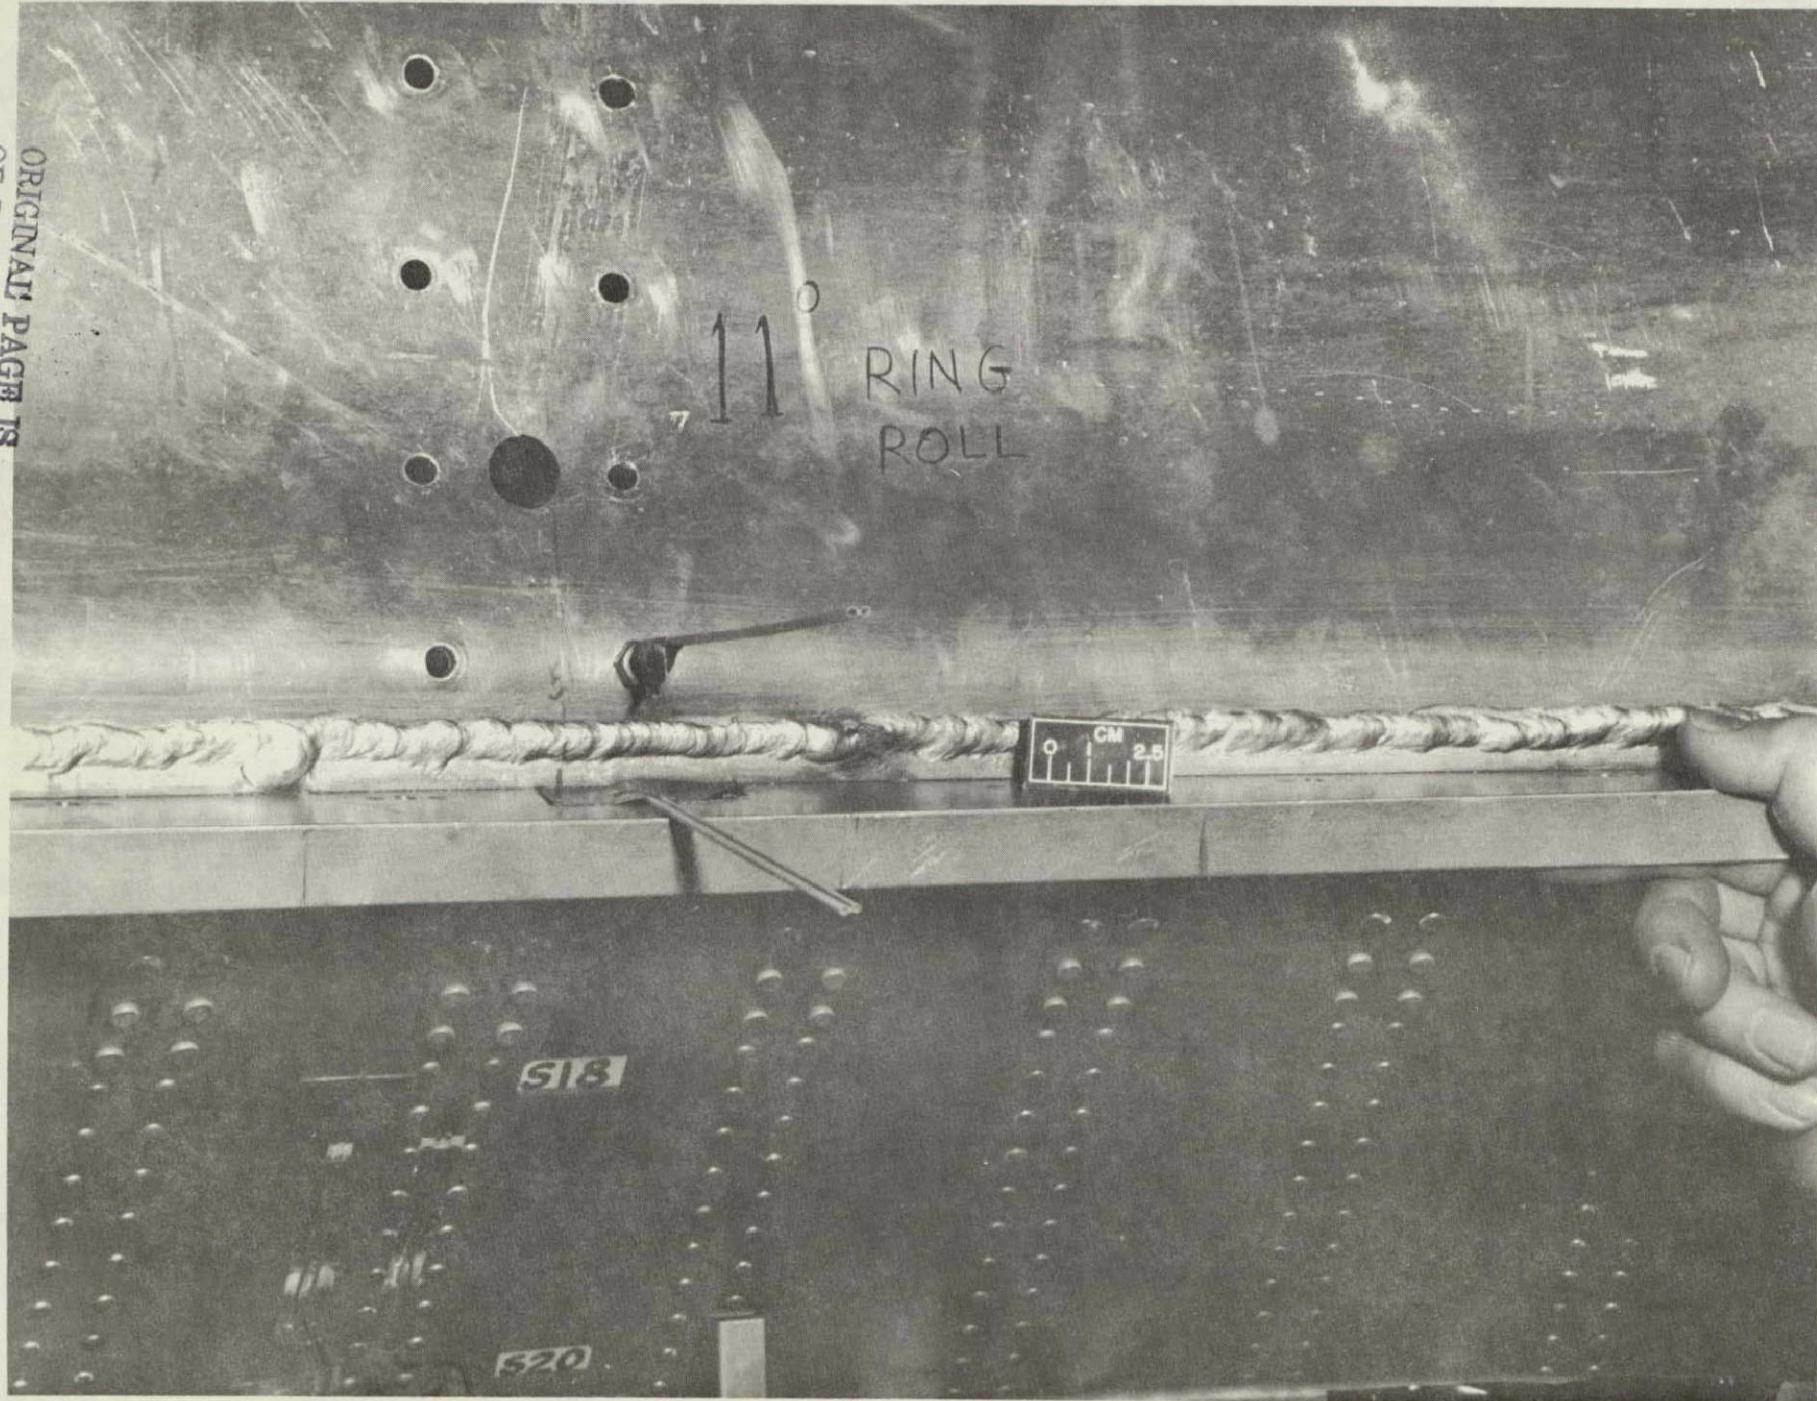
FIGURE 25 - INTERNAL VIEW OF DISTORTION IN E/M FORWARD RING ON COMPRESSION SIDE

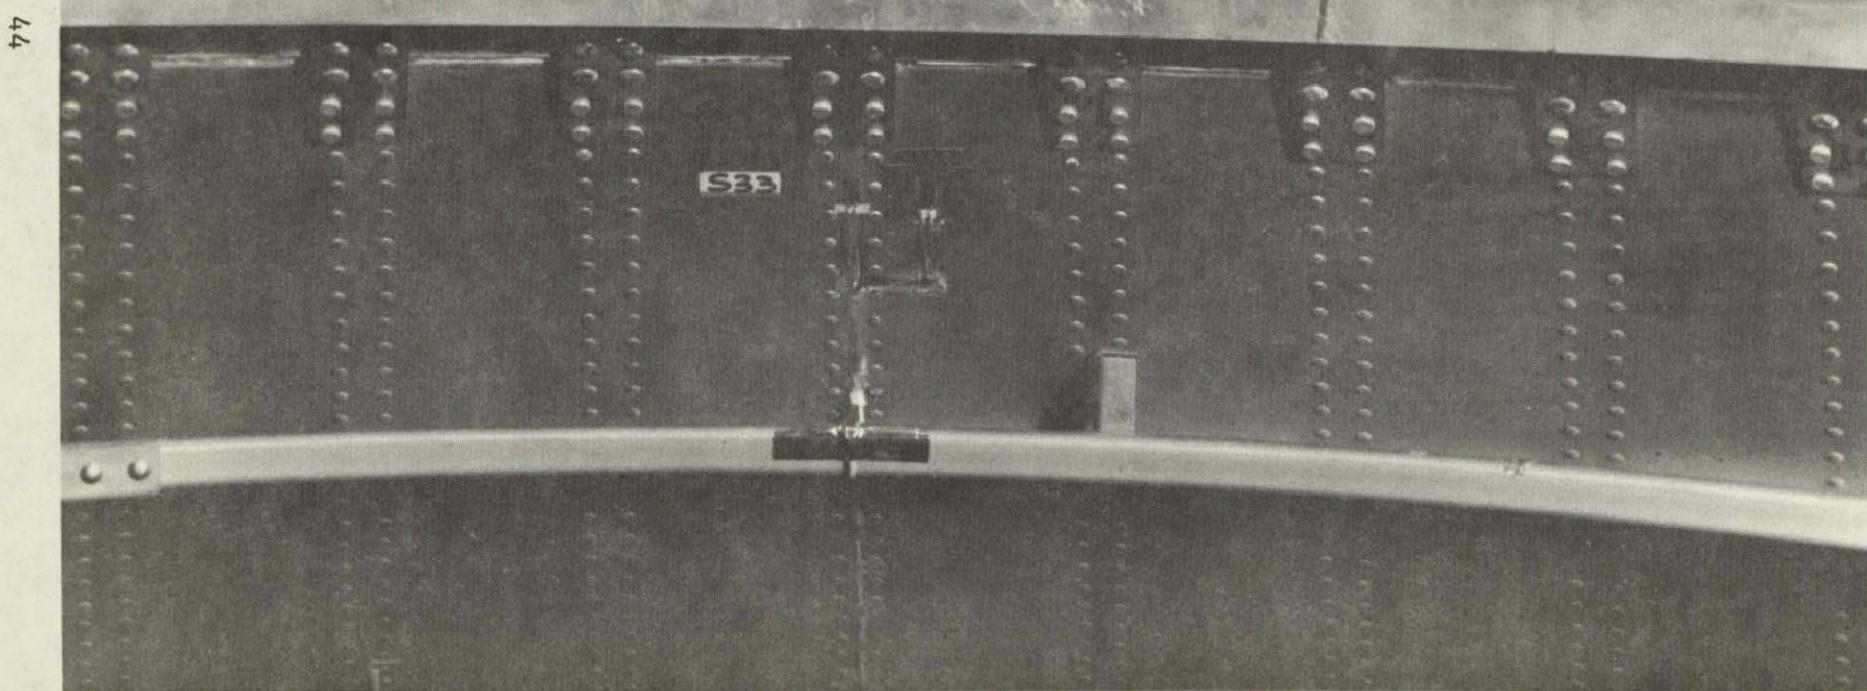
FIGURE 26 - INTERNAL VIEW OF DISTORTION IN E/M FORWARD RING ON TENSION SIDE

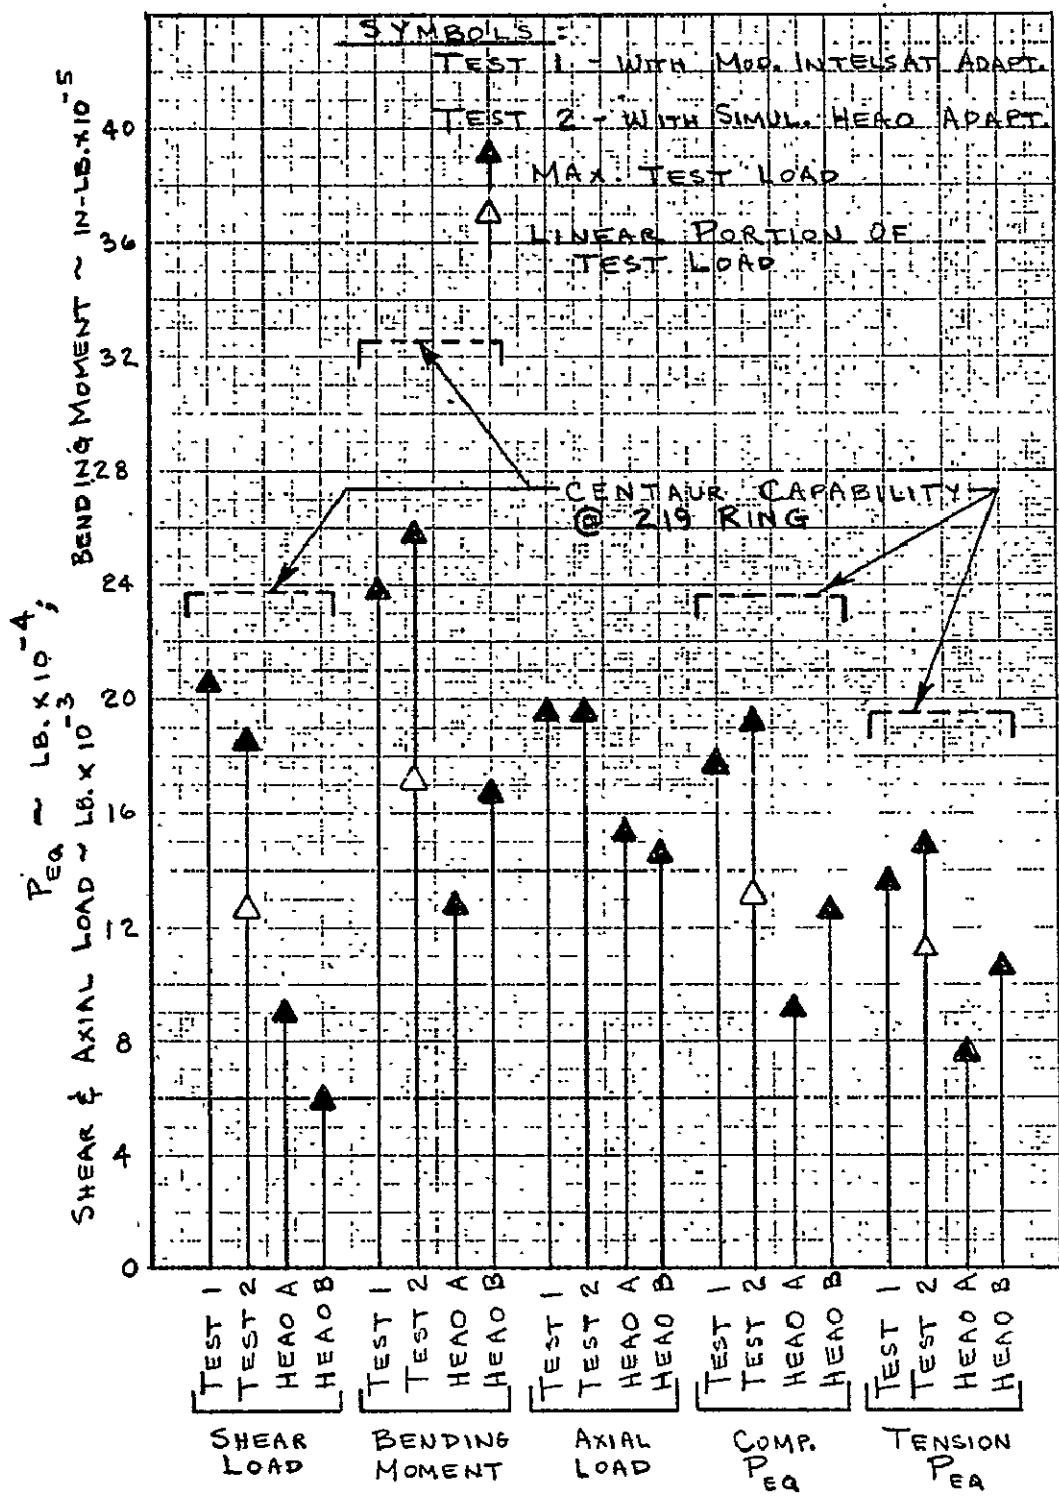
FIGURE 32 E/M TEST LOADS COMPARED TO HEAD A AND HEAD B PREDICTED FLIGHT LOADS

Figure 32 compares the maximum test loads which were applied to the E/M in the two failure tests to the HEAO mission predicted maximum flight loads. As this figure indicates, the E/M supported loads well in excess of these loads and is structurally qualified for these missions.
